## **GIBSONS OPEN CUT REMEDIATION**

Five SOMR members took the trek to Halls Peak on Sunday March 9<sup>th</sup> to check on restoration works in response to our discovery and alerts to the EPA and Derelict Mines Office about toxic sludge being inappropriately placed after removal from sediment dams.

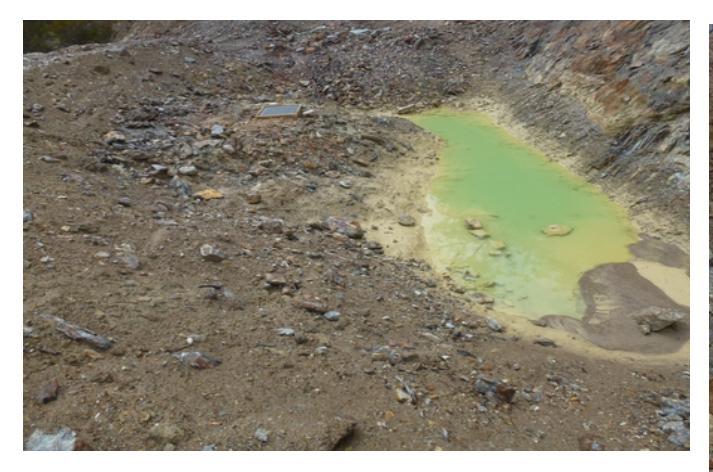
We initially inspected the top dam where the two sulfurous deposits previously inappropriately placed on the top and outside dam walls has either been removed or incorporated into the structure of the dam wall.

The pH of the aquamarine water was measured at 3.3 at a temperature of 23.3 degrees Celsius.

(here could be a before and after. I haven't got a good photo from the first visit of the yellow sediment on the dam wall)

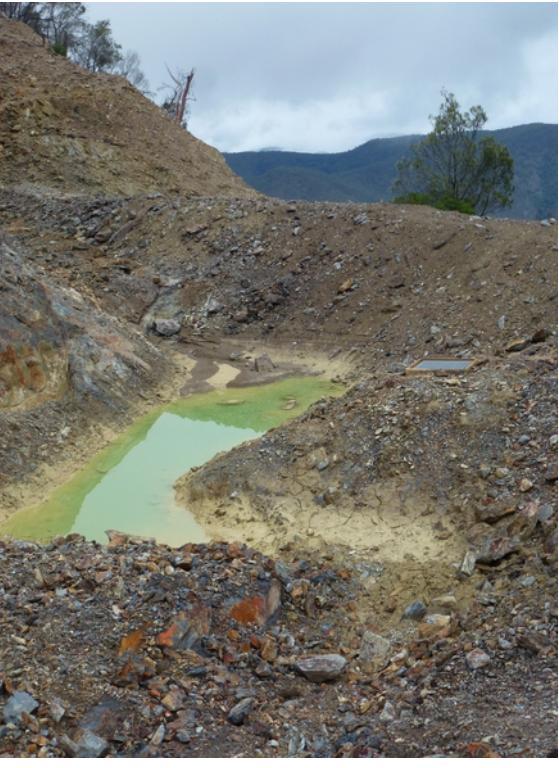
We took some time to observe the construction with an internal grid drain that seems to feed out below as well as restoration of the overflow culvert. Both are apparently designed to channel water within the mine footprint to collect sediment on-site.

The loose nature of the scree and gullies eroded from rain gave us an indication of the instability of the site and the difficulty designing and constructing these control features.

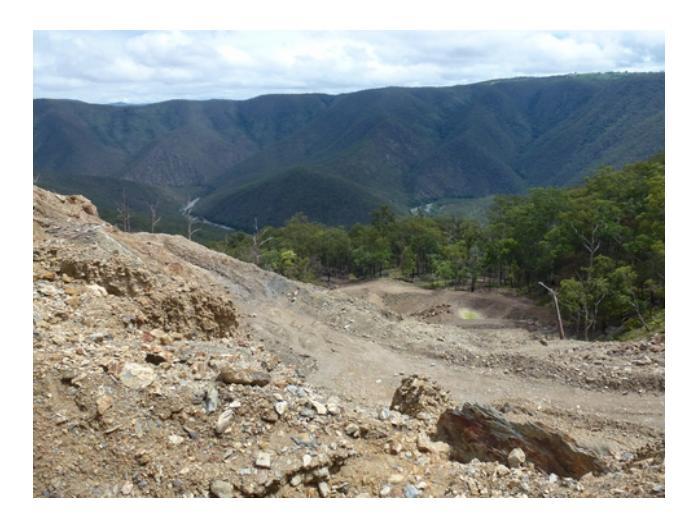
Slightly further down the site we noticed an area that appears to have been recently disturbed and worked back and forth with the tracks of machinery such as an excavator or loader. Photos were taken to ask DMO if this is the location of the new containment cell. (left photo)

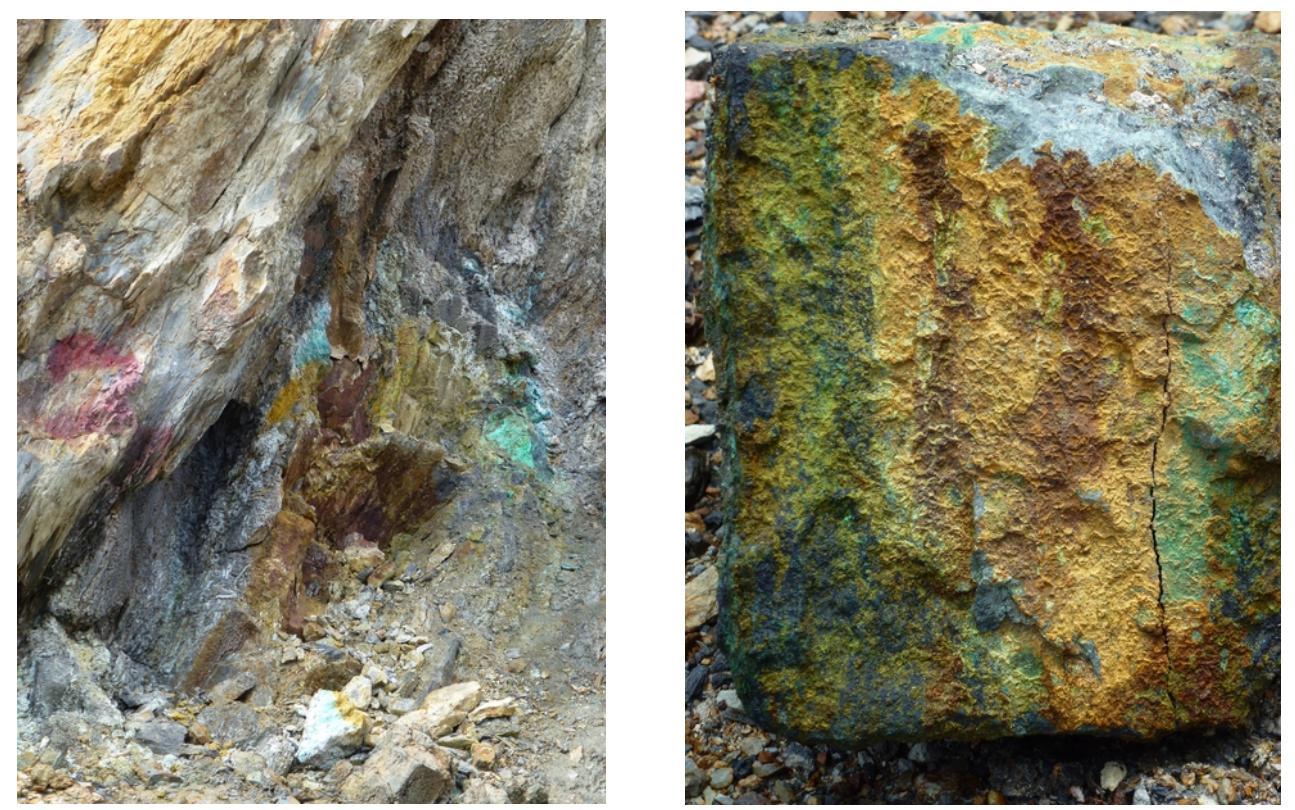
dam" another level down?) and the Gibsons shaft above which runs horizontally into the cliff face for about 20 metres before being blocked by a rockfall. This shaft seems to get quite wet either from internal seepage or from water entering via the cliff face.

This area contains highly coloured rocks indicating signs of mineral content that no doubt attracted the original miners.

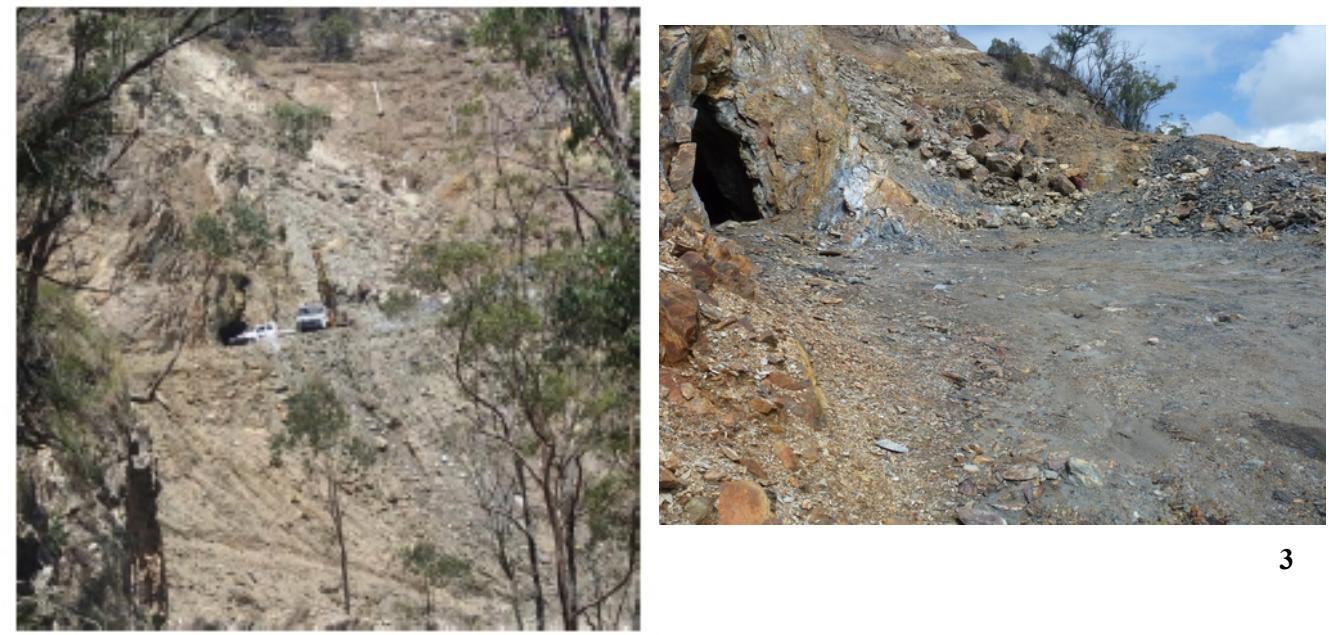
Late last year Precious Metal Resources (PMR) carried out exploration drilling in front of the shaft. The area has recently been levelled and no other trace of that work is left.

PMR drilling in progress at former Gibsons Mine

Left: from PMR report January 2014 Right: March 2014 From there we progressed to the bottom of the site where the 3 lower dams are the last opportunity for sediment to be trapped and maintained on the site.

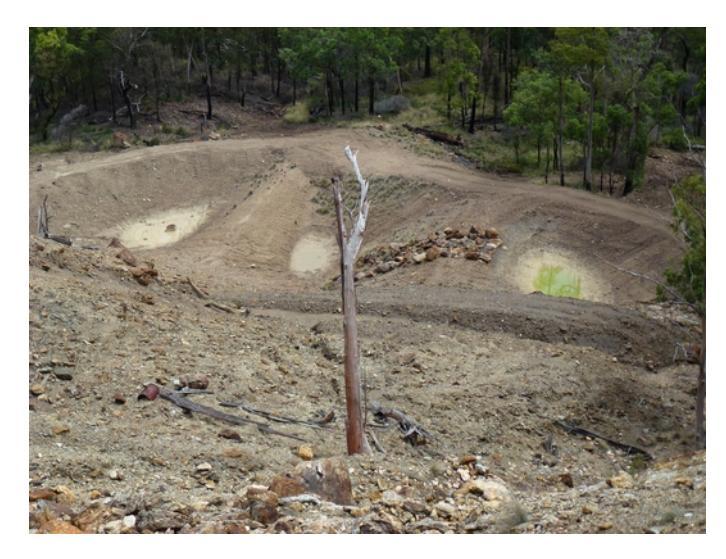
This is the area where on our first visit we found toxic sediment deposited outside the containments flowing down the slope towards the Chandler River. This sediment has now been removed and quite extensive work has been done including a new small containment area with a dam wall.

It was reassuring to see the excavation had included the band of flow that had tracked down the gully for some distance and that erosion control measures have been constructed. It seemed that only a small area of the sediment we had seen before remained between larger trees that obviously was inaccessible to mechanical equipment.

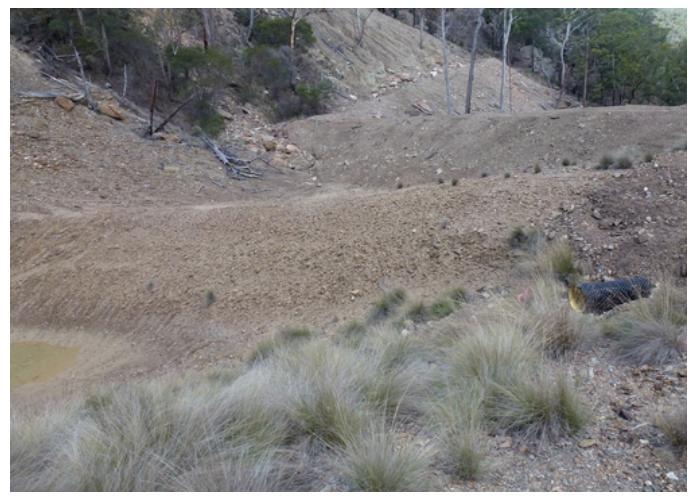
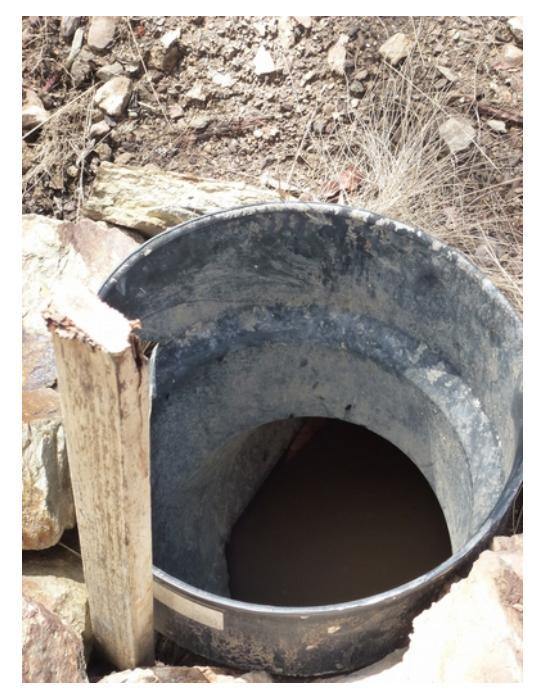
In the three lowest dams we observed sticks, leaves and a large log trapped in the rubble of the overflow drain indicate that this is at times a high energy system.

The middle dam has an overflow pipe that runs underground to an area outside and exits vertically to reduce flow velocity and erosion.

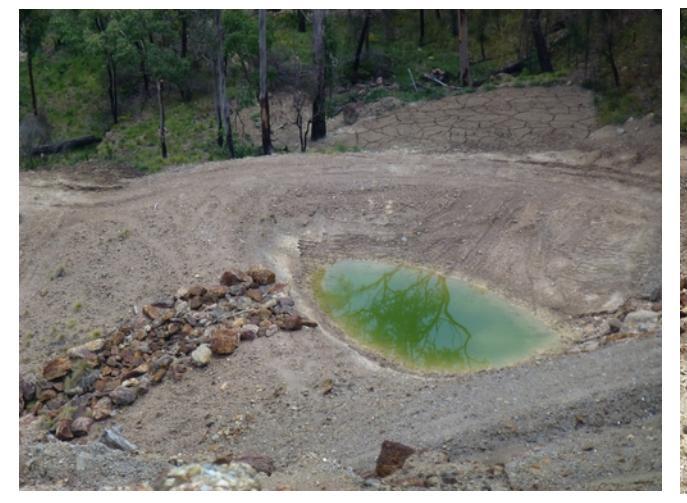
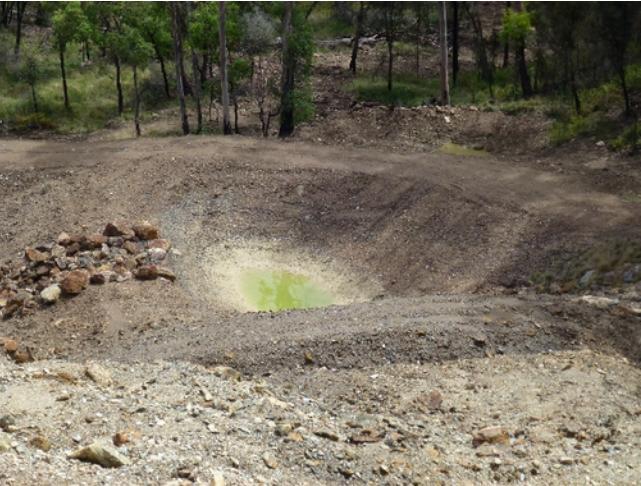
On observing and discussing the site, comparing this and the previous visit as well as numerous site photos, we could not understand how the sediment flow could possibly result from a breach in a bund wall. Above where this sediment was there is only the access road over the dam wall. The bund wall below is new.

Lower dam November 2013 with cracked sediment

March 2014. Cracked sediment removed, new bund walls beyond the dam

We are awaiting an explanation from DMO who have suggested it flowed from a broken containment cell bund wall. We maintain from the topography and our observations that this sediment was placed there inappropriately.
